ANALYZE YOUR WAY TO LONGER LASTING, BETTER PERFORMING V-BELT DRIVES

> Introduction

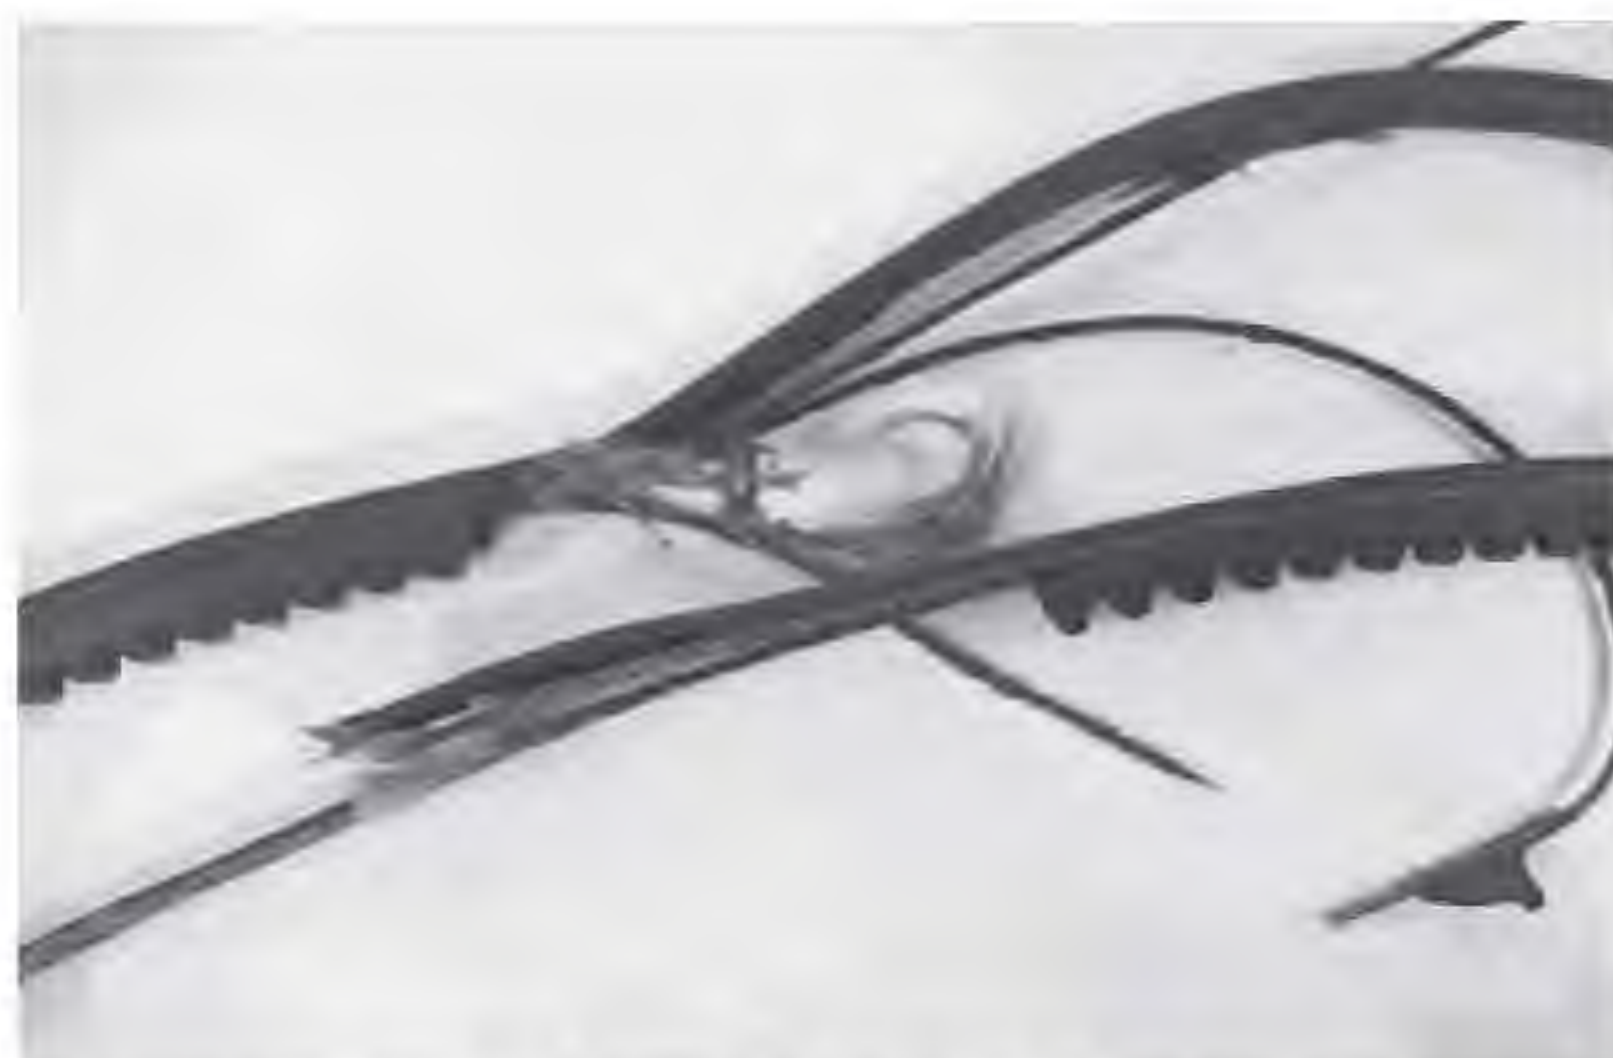
Figure 1 - Normal V-belt failure is characterized by a break or separation.

Any mechanical component fails eventually. When a V-belt has reached the end of its useful life, it will pull apart, or break, indicating that it can no longer carry the load it was designed to carry in the drive system. (See Figure 1)

Time is the key differentiator. If the belt is failing more often than expected, the cause is abnormal wear. If it fails in this manner after years of service, consider it “normal” failure.

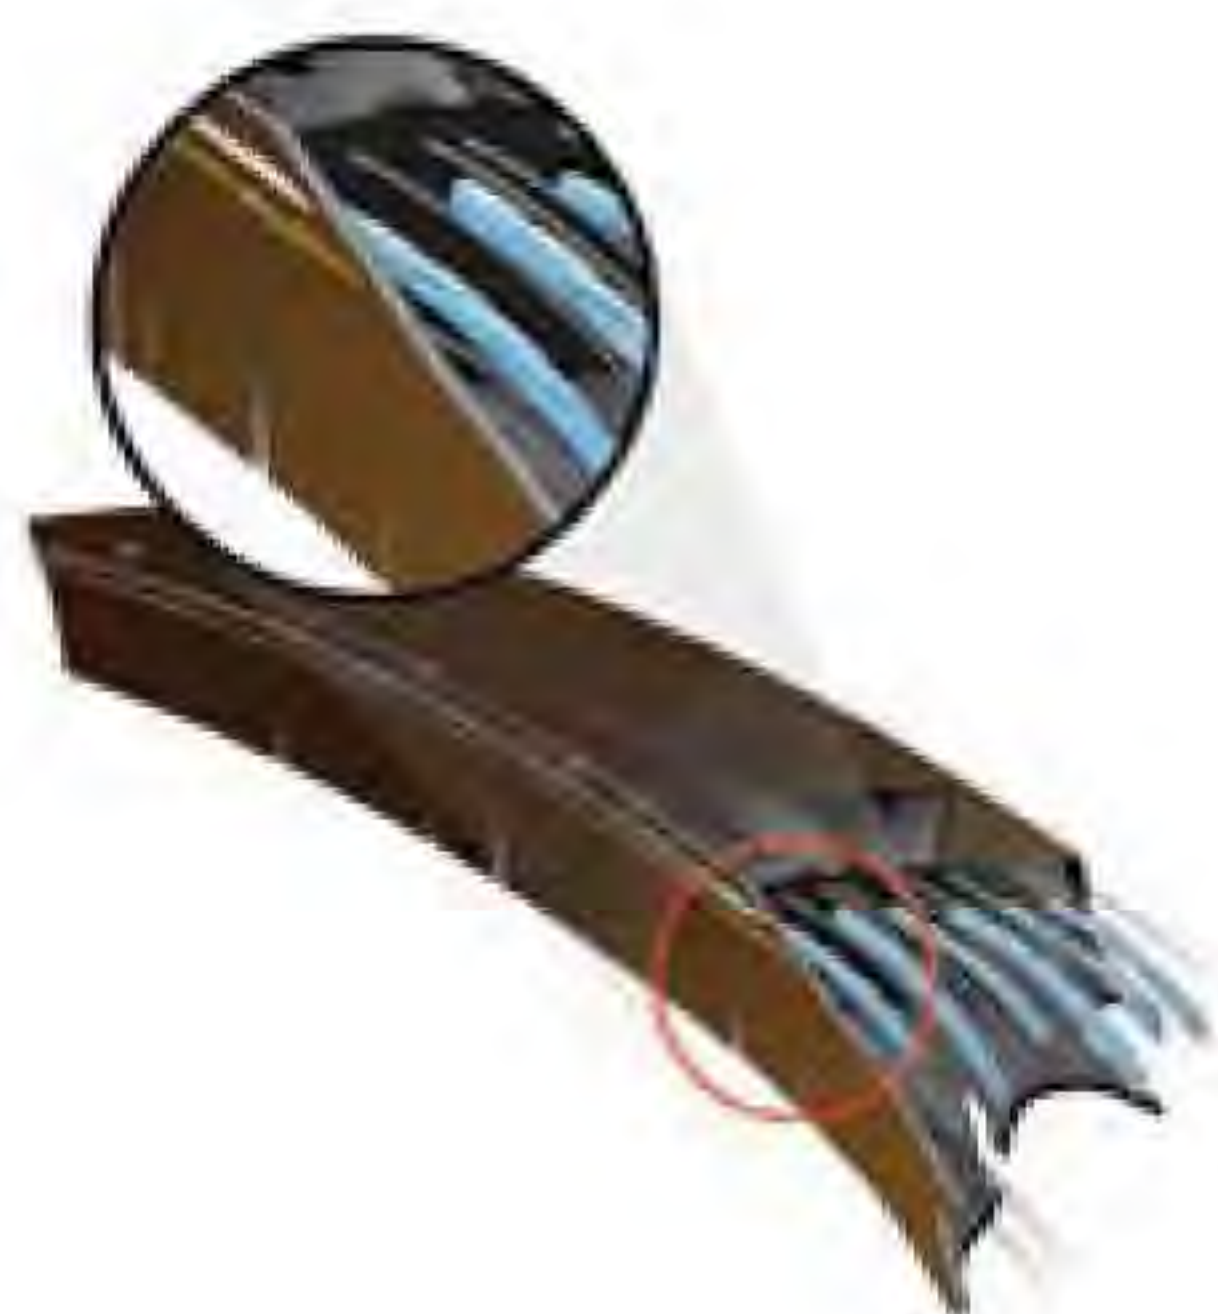
Figure 6 - Broken belt

When a V-belt fails prematurely it may break (see Figure 6), delaminate, or slip to the point where it can't carry the load. These signs are almost identical to normal failure at the end of a belt's useful life, so how do you tell the difference? Time. If the drive design projects a two-year service life and the belt breaks after two months, you can be sure the failure is abnormal. Start looking for a problem with the drive and correct it before replacing the belt.

An under-designed drive or severe shock load also might cause the belt to break prematurely. Solving this problem involves redesigning the drive. Another cause of a clean break might be an object falling into the drive, which could be solved by providing better guard protection. Or the installer may have pried or rolled the belt onto the sheave, damaging the tensile cords. This problem is solved by providing adequate take-up when installing a new belt.

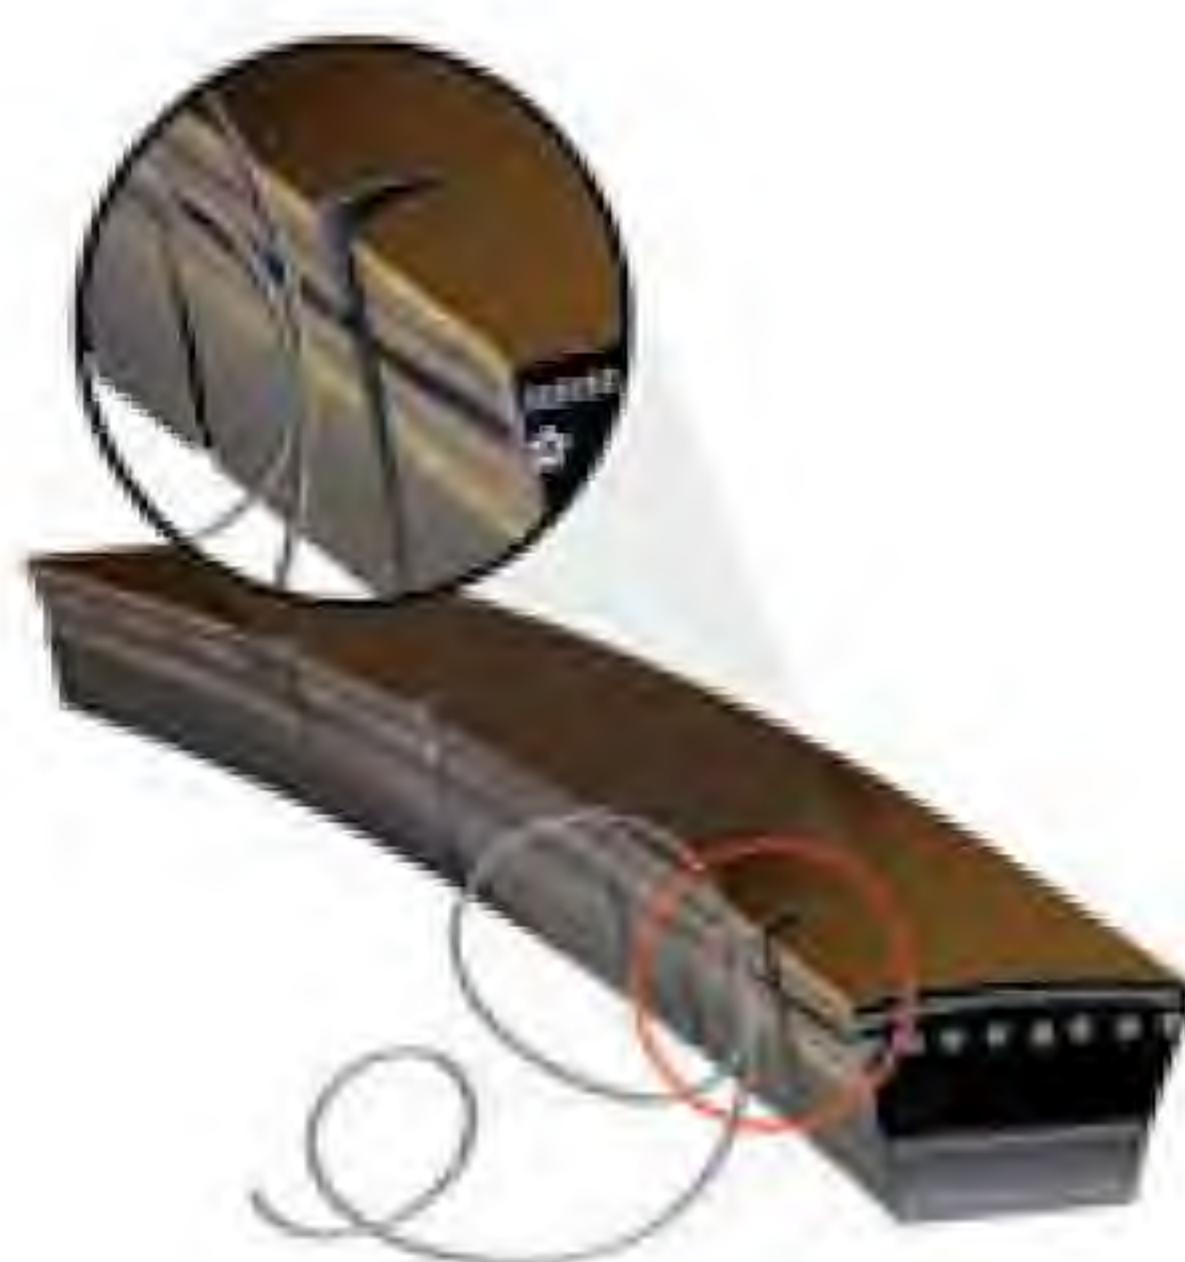
Figure 7 - Edge cord failure

Another type of premature failure is edge cord failure (see Figure 7) due to sheave misalignment or a damaged tensile member. Correcting this problem involves checking and correcting the alignment, and following correct installation procedures when installing a new belt.

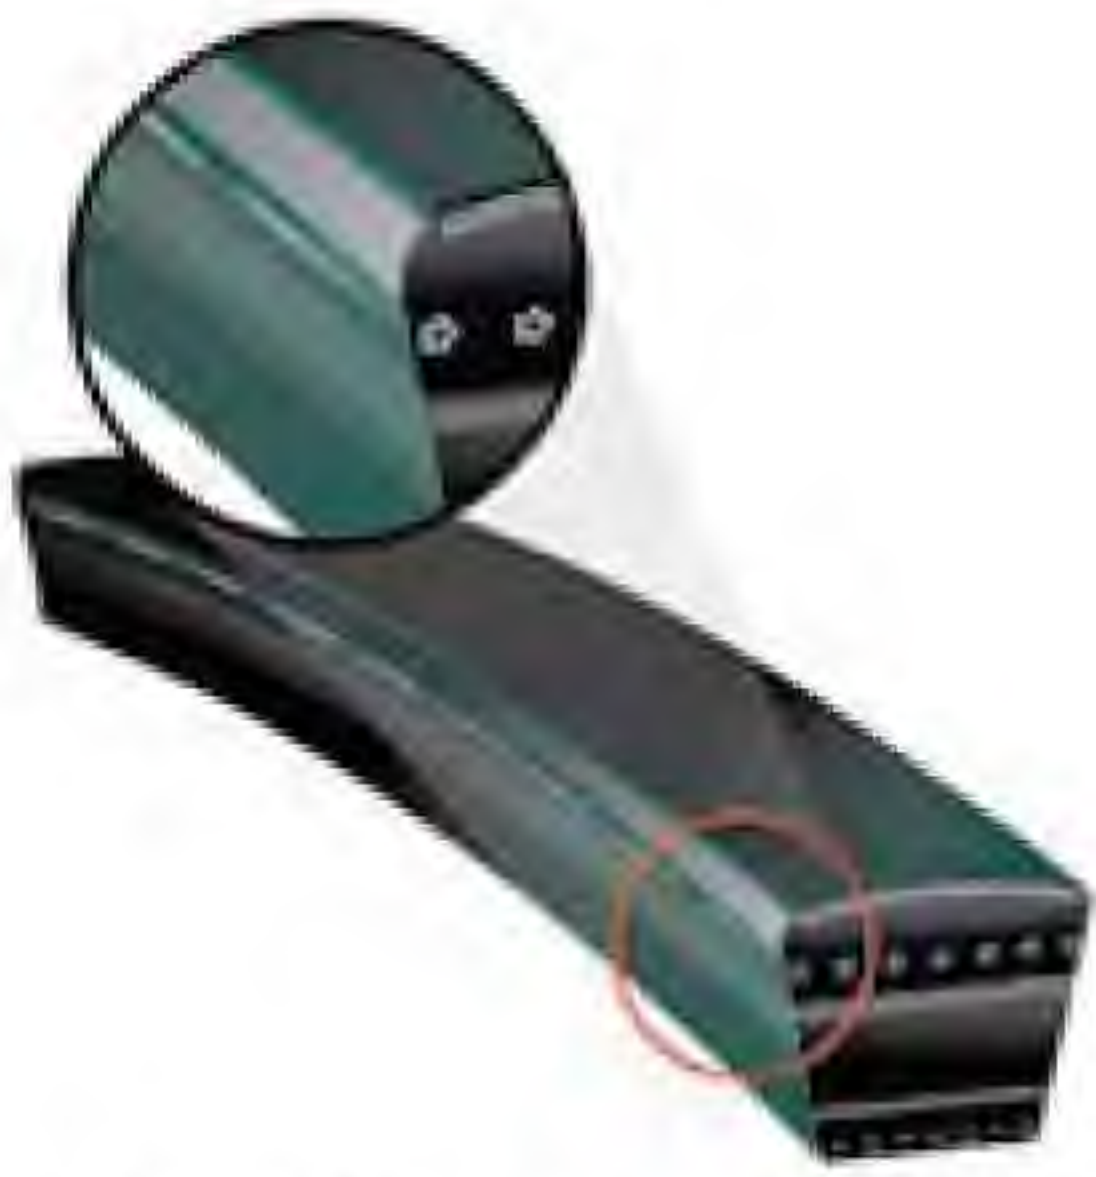
Figure 8 - Wear on top corners

Wear on the **top corners** (see Figure 8) of the belt may indicate that the belt is too small for the groove in the sheaves. Matching the belt to the correct sheave will solve the problem.

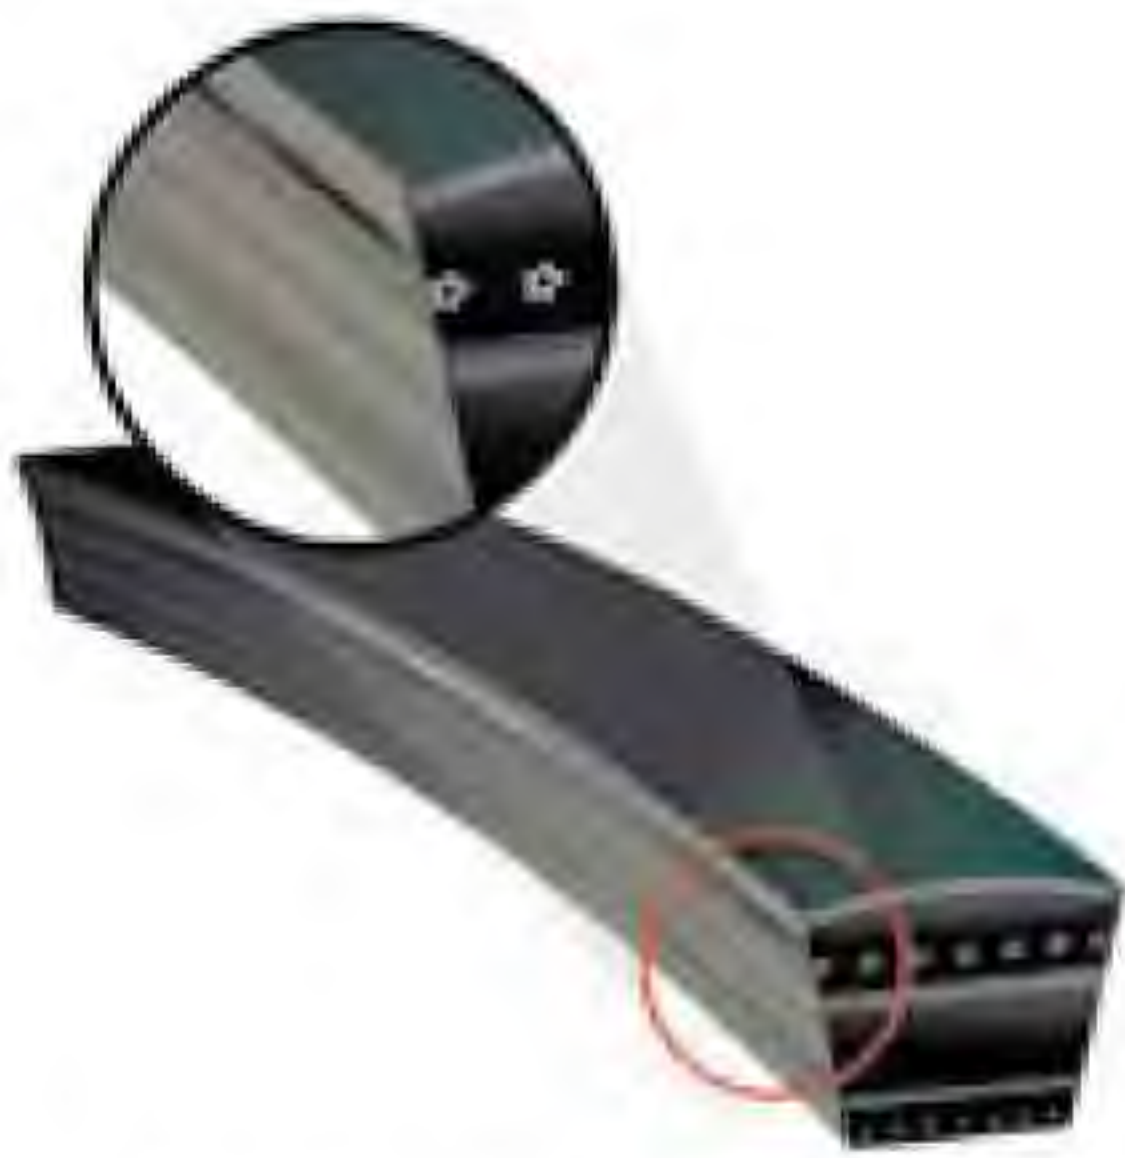
Figure 9 - Wear on belt sidewalls

Excessive wear along the **belt sidewalls** (see Figure 9) could be caused by several factors. The belt could be slipping due to incorrect tension. If so, retension the drive until the slipping stops. Another potential problem is sheave misalignment, which requires realigning the drive. In this case, replace the sheaves. Or the belt may simply be the incorrect size and needs replacement with the correct size.

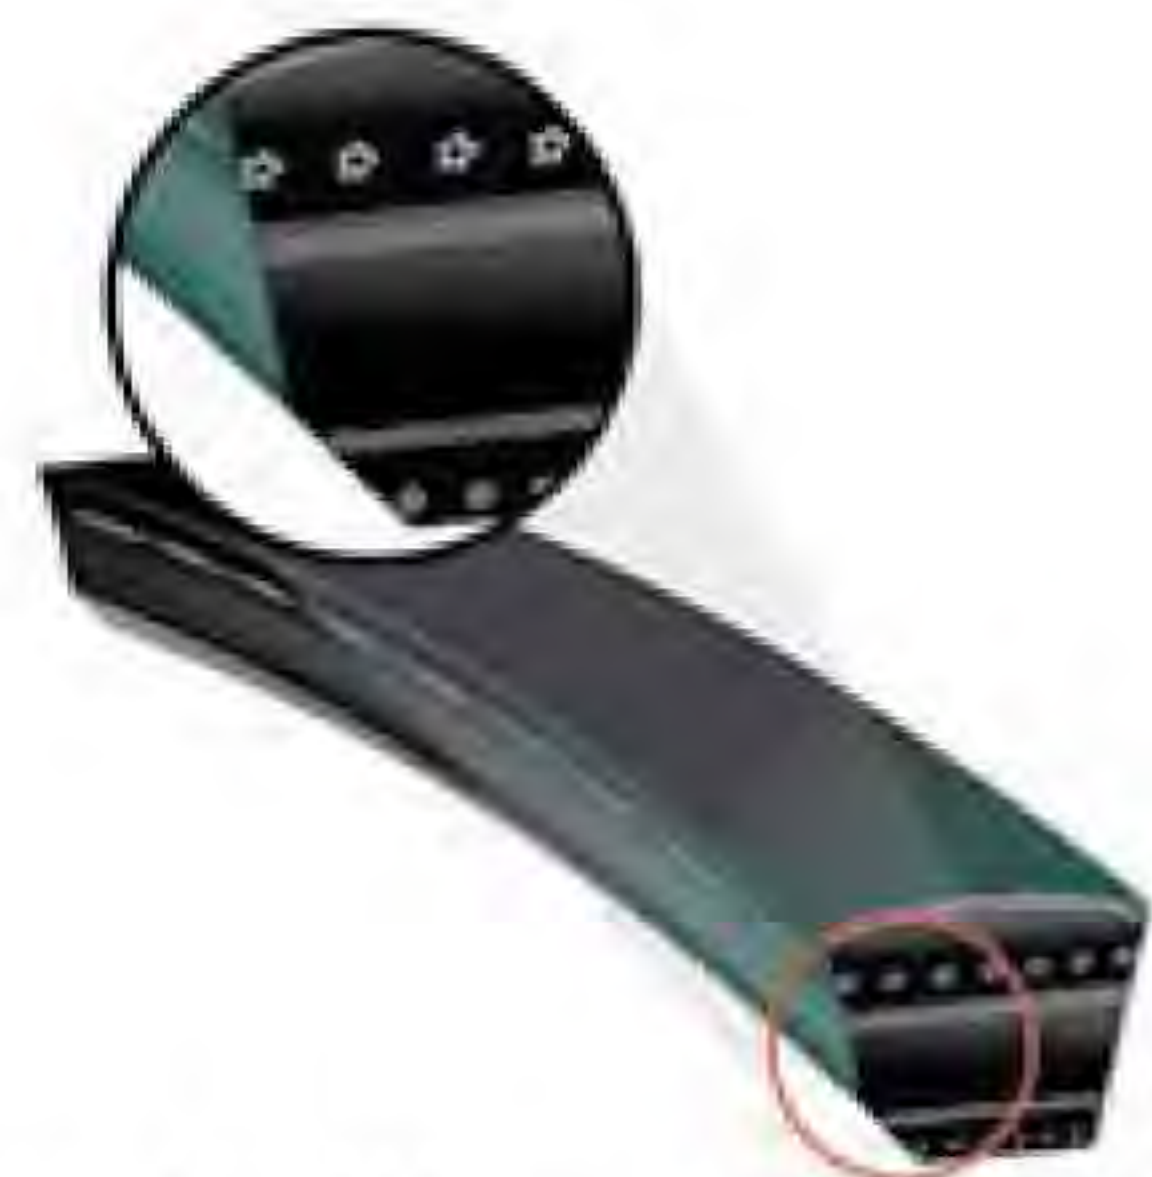
Figure 10 - Wear on belt bottom corners

Wear on the **bottom corners** of the belt (see Figure 10) could be due to worn sheaves or an incorrect fit between belt and sheave. Check the sheaves for wear and replace them if necessary, or find the correct belt/sheave match.

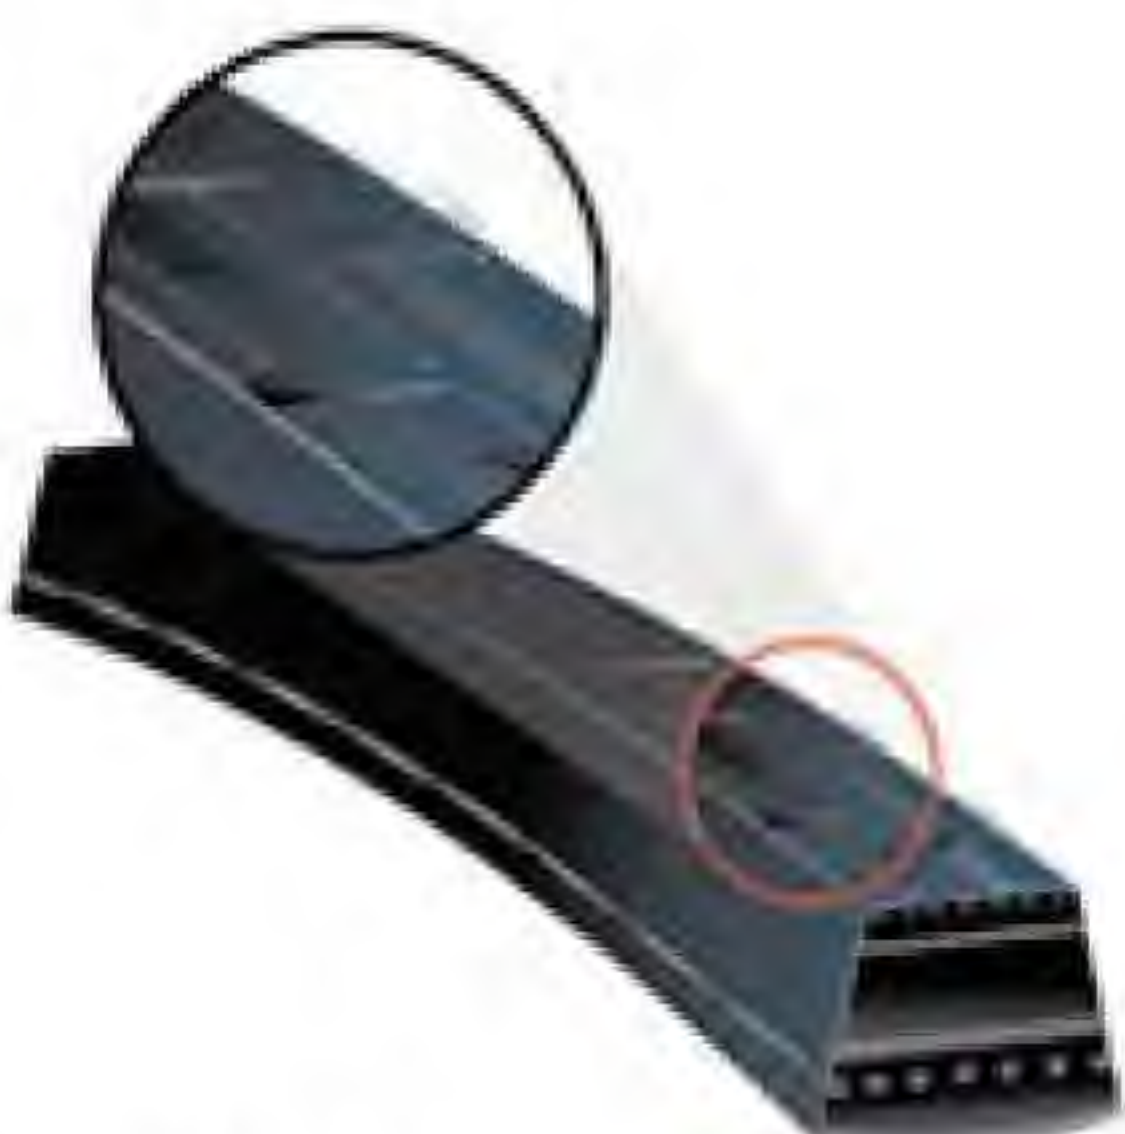
Figure 11 - Bottom surface wear

Bottom surface belt wear (see Figure 11) could be caused by debris in the sheaves, sheave wear, or the belt bottoming out against the sheave grooves. Bottoming out is caused by an incorrect match between belt and sheave, and can be corrected by finding the proper match. If the sheaves are worn, replace them, and if debris has gotten into the sheaves, clean them.

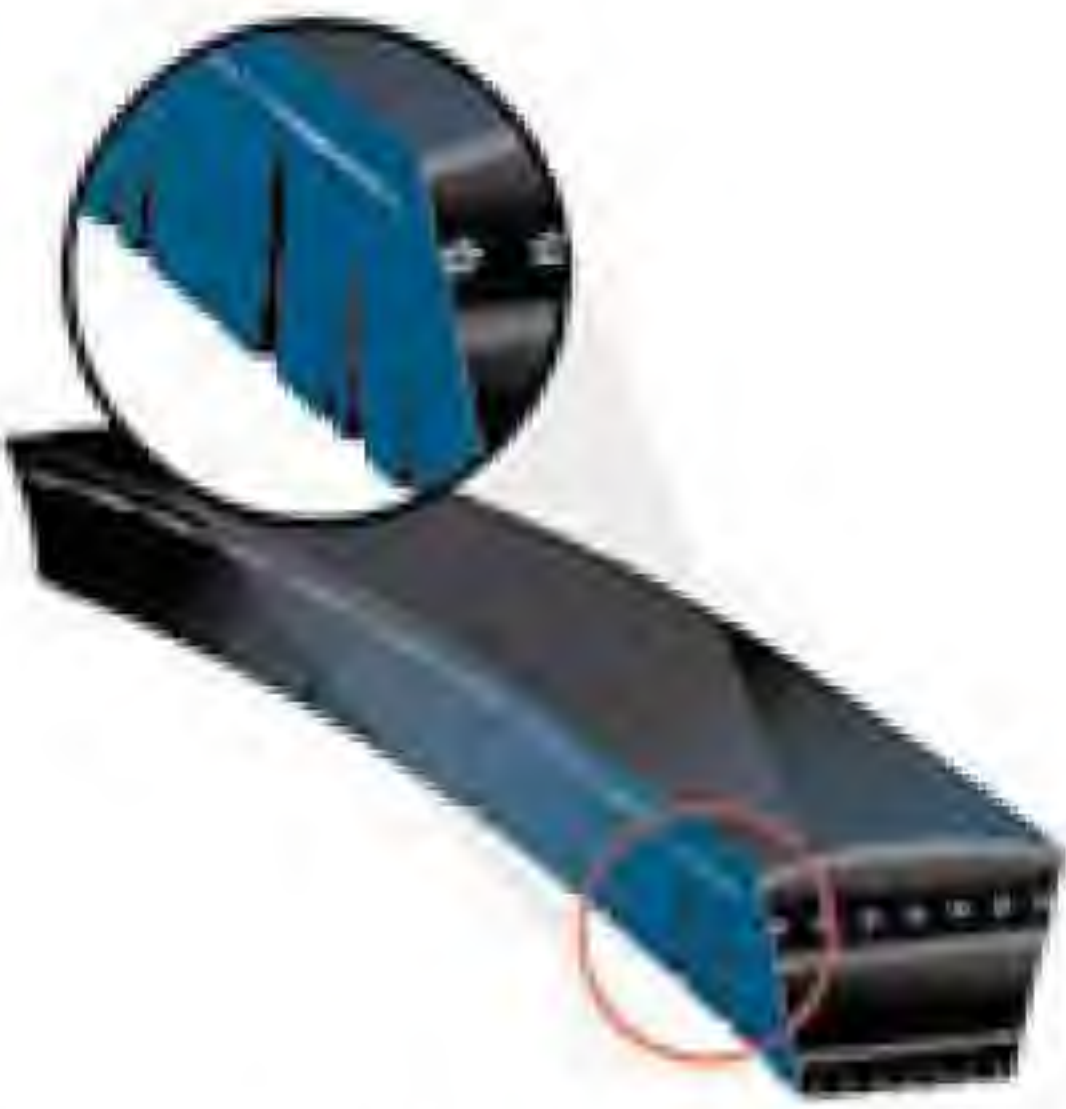
Figure 12 - Undercord cracking

Undercord cracking (see Figure 12) may be due to a number of factors. Environmental conditions (excessive heat or cold) or improper storage could be to blame. Solutions involve controlling the belt drive environment and following proper storage and handling procedures. Another cause might be belt slip, corrected by retensioning the belt to the manufacturer's recommendations. A sheave that is too small for the belt section, causing the belt to wrap too tightly around the sheave, could crack the undercord. Replacing the small sheave with a larger one could correct the problem. Similarly, a backside idler with too small a diameter could be the problem, fixed by increasing the size of the backside idler.

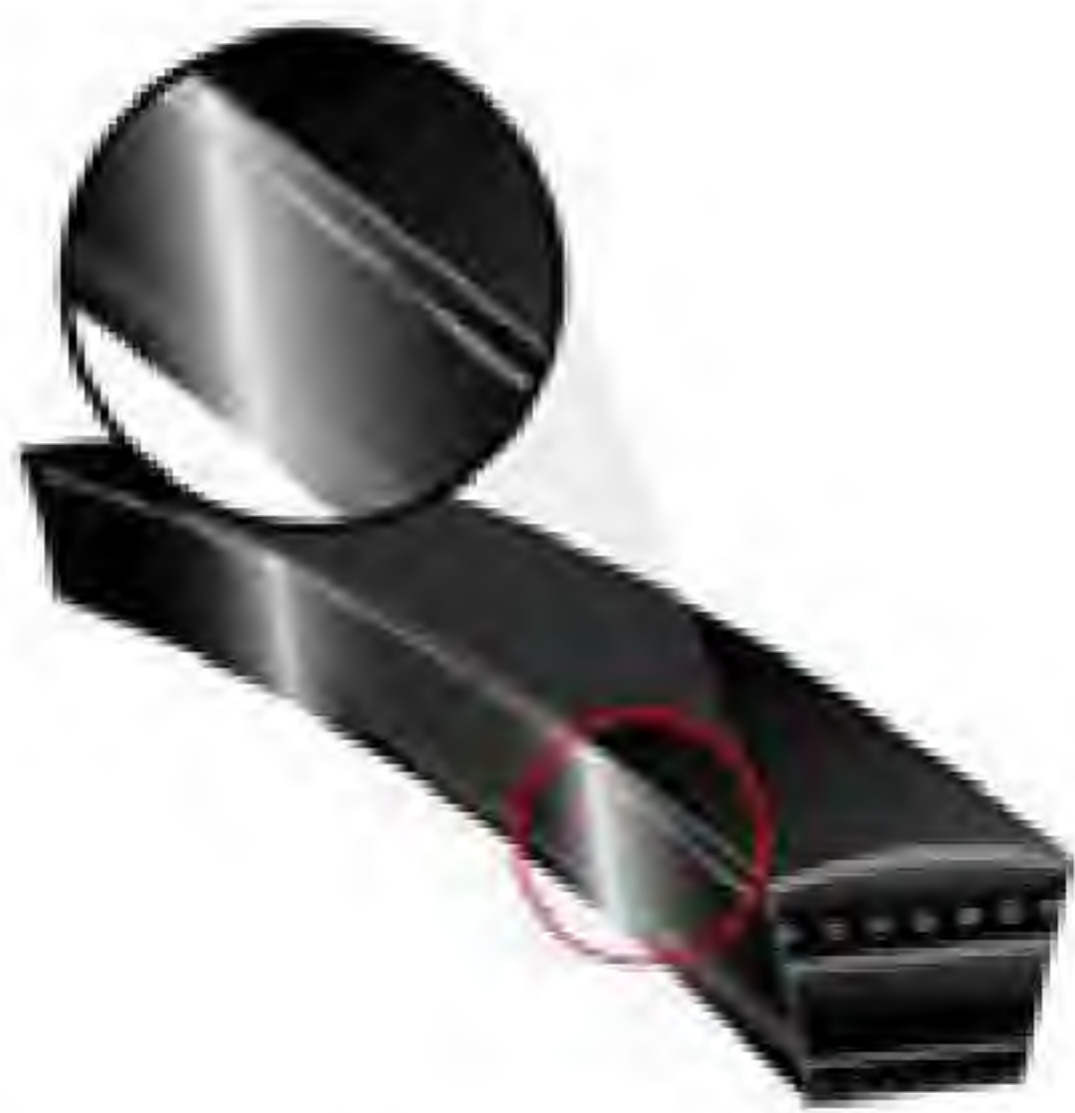
Figure 13 - Sidewall burning or hardening

Sidewall burning or hardening (See Figure 13) is a sign of belt slip, worn sheaves, an under-designed drive or shaft movement. A slipping belt should be retensioned to the manufacturer's recommendations. A worn sheave should be replaced. If the drive is under-designed and can't carry the load, redesign it to the manufacturer's recommendations. Shaft movement might be caused by changes in the center distance between the sheaves, and should be checked and adjusted.

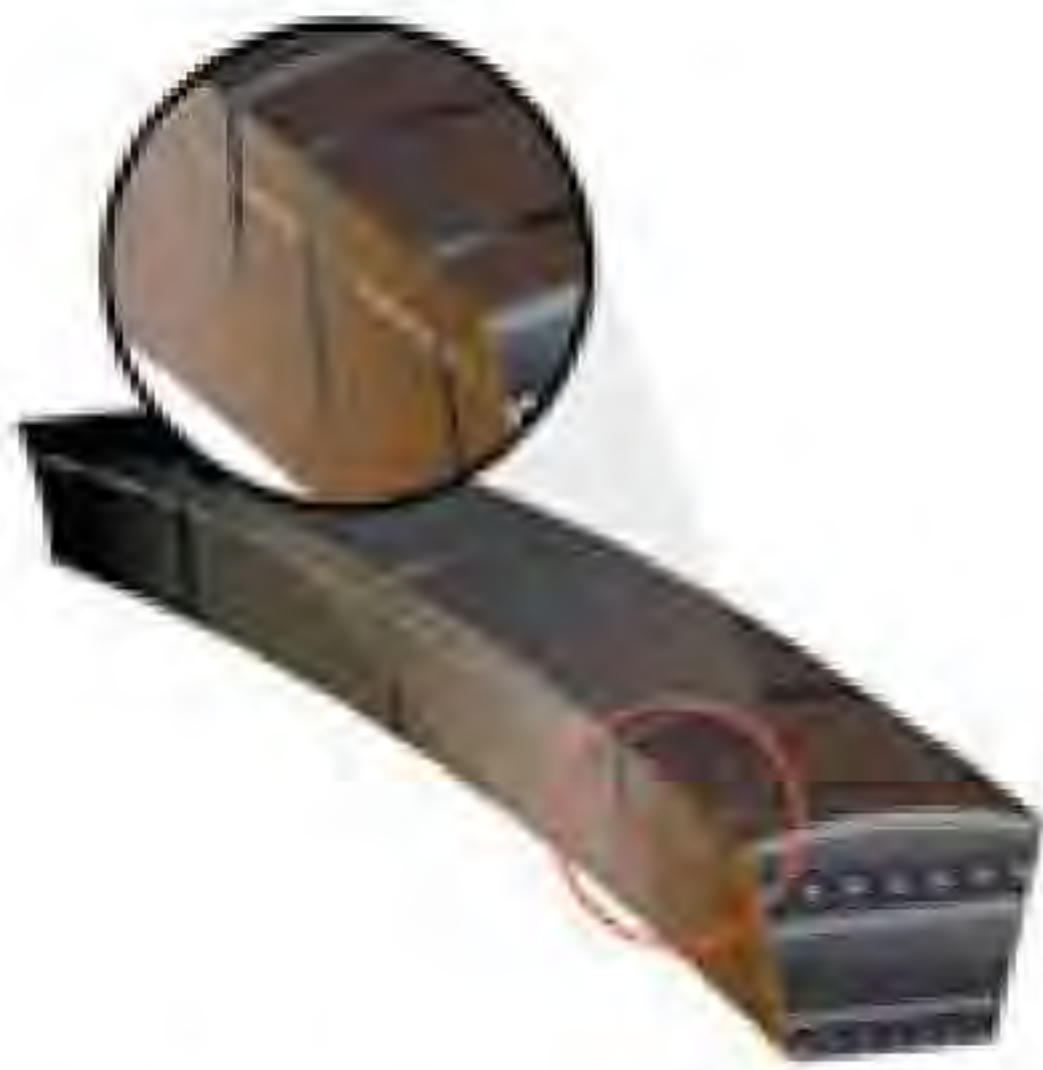
Figure 14 - Belt surface hard or stiff

If the **belt surface** is hard or stiff (see Figure 14), it might be due to an excessively hot environment or to belt slip. Correct the problem by providing more ventilation to the drive or adjusting belt tension.

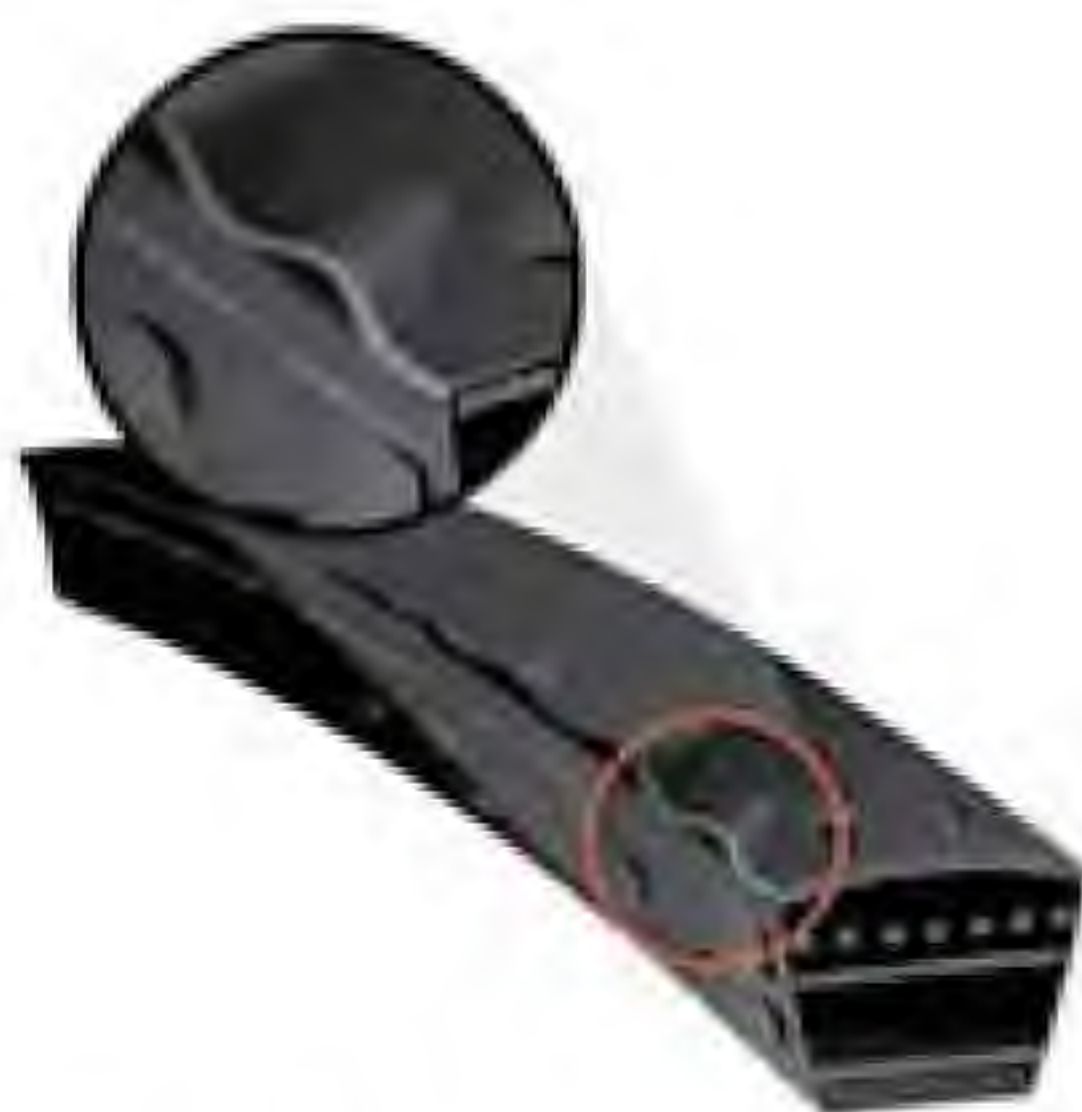
Figure 15 - Belt surface flaking, sticky or swollen

A **belt surface that is flaking, sticky or swollen** (See Figure 15) may have become contaminated by oil or chemicals. Eliminate the source of the contamination, and never use belt dressing.

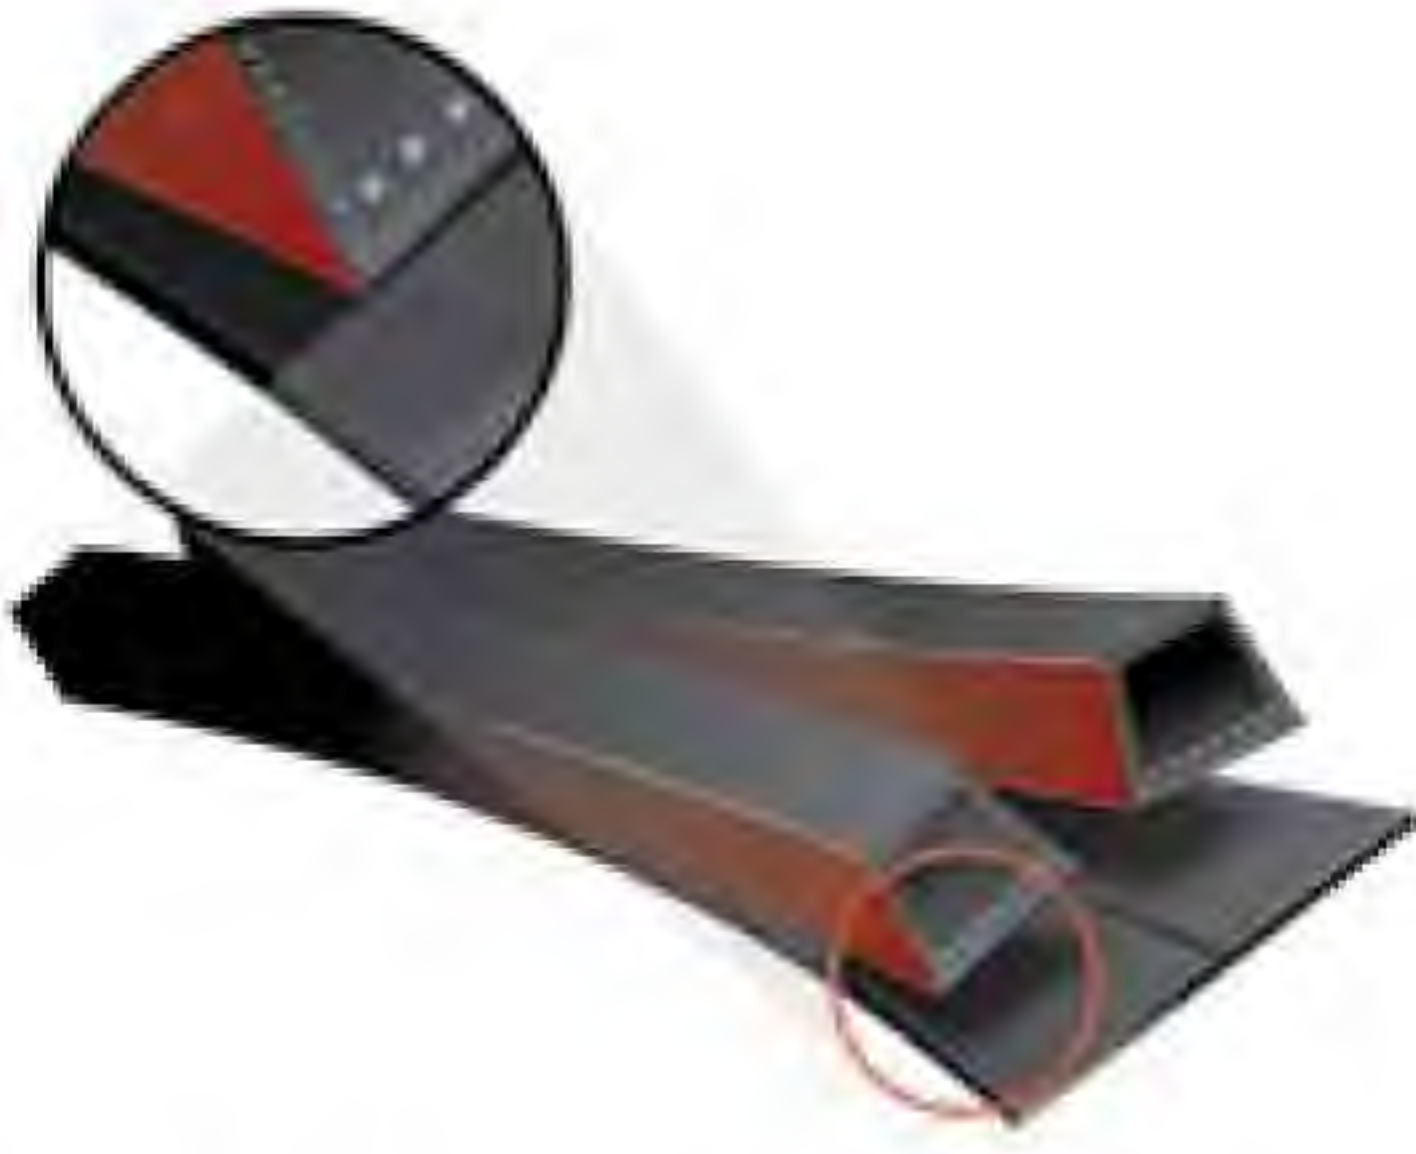
Figure 16- Tie-band separation

Tie-band separation (See Figure 16) might be the result of improper groove spacing. Check the sheaves to ensure that they have been manufactured to industry specifications. Another cause might be worn or incorrect sheaves, which requires replacing the sheaves. Also check to see if the sheaves are misaligned, which could force a separation of the tie-bands. Realign the drive to correct the problem.

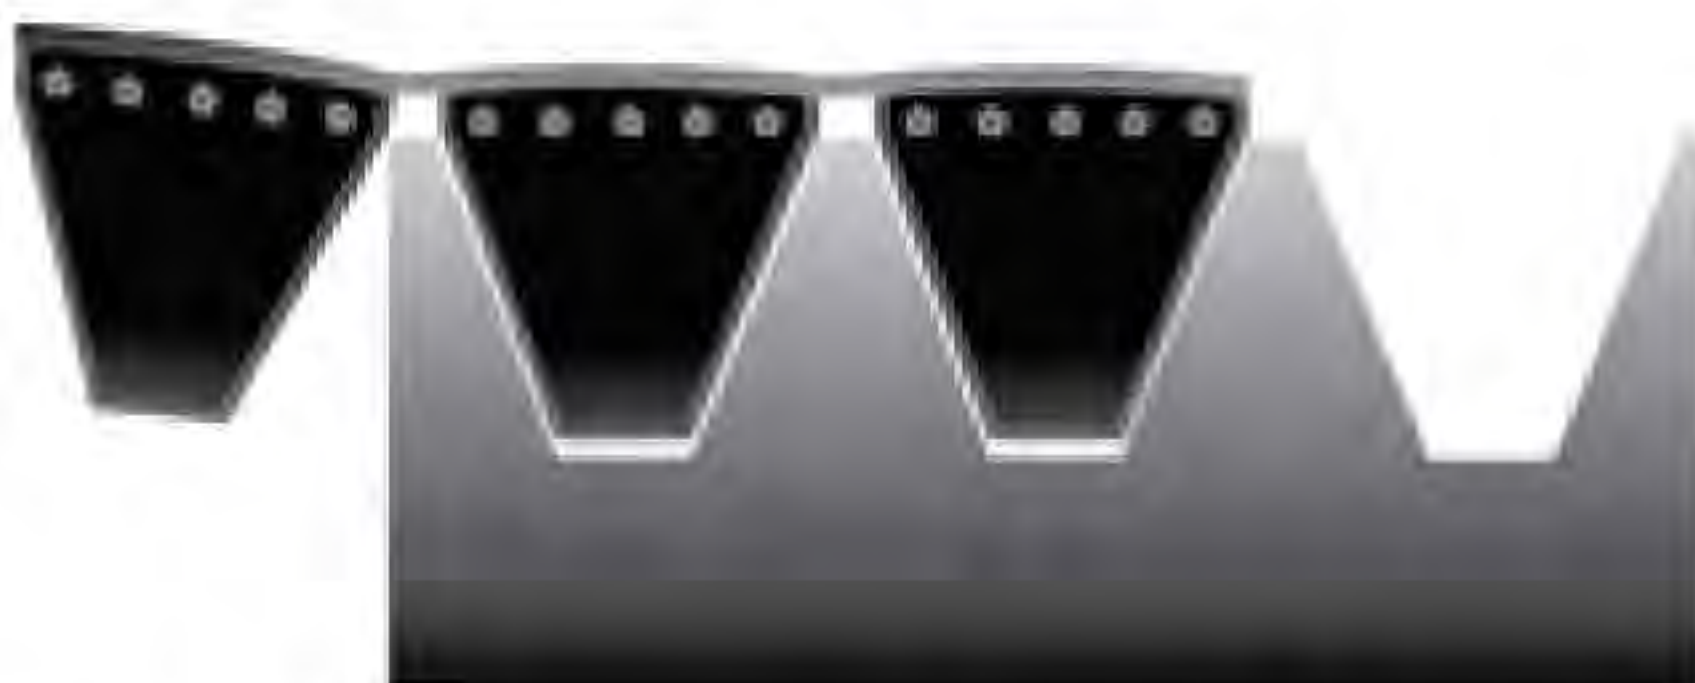
Figure 18 - Belt rib runs outside sheave

A belt that has **one or more ribs running outside the sheaves** (see Figure 18) could be undertensioned. Check the manufacturer's specifications and retension the belt. Another possible cause is sheave misalignment. Realign the drive to correct the problem.

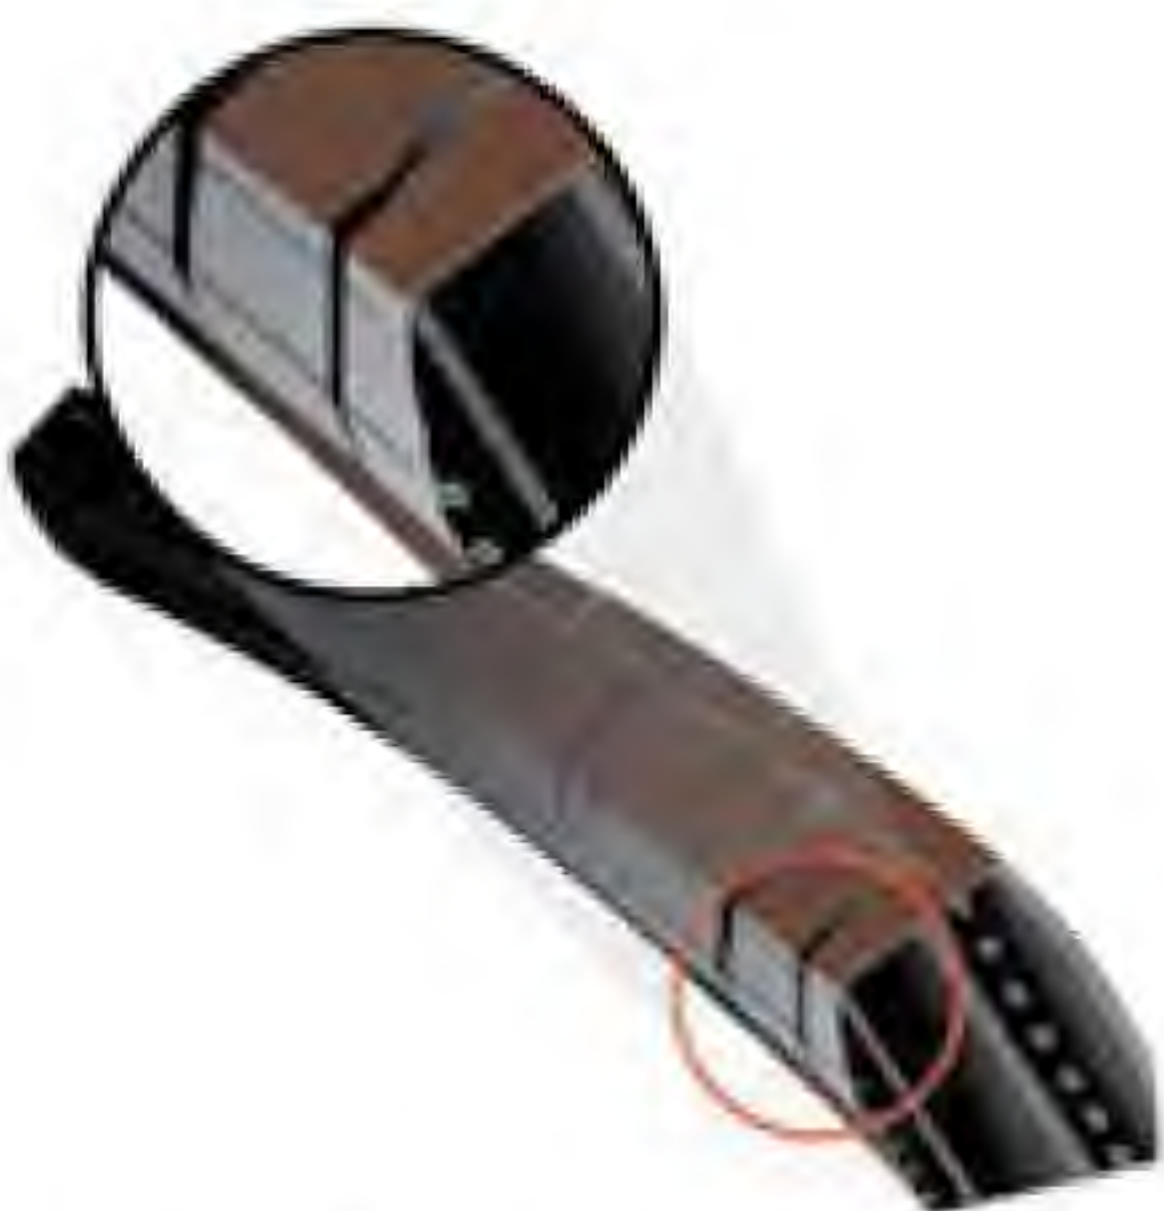
Figure 19 - Belt turns over or comes off sheave

Two problems common to both single V-belts and multiple V-belts include belts turning over or coming off the sheave (See Figure 19), and belts stretching beyond the available take-up.

There are a number of probable causes and corrective actions for single or multiple V-belts turning over or coming off the sheave:

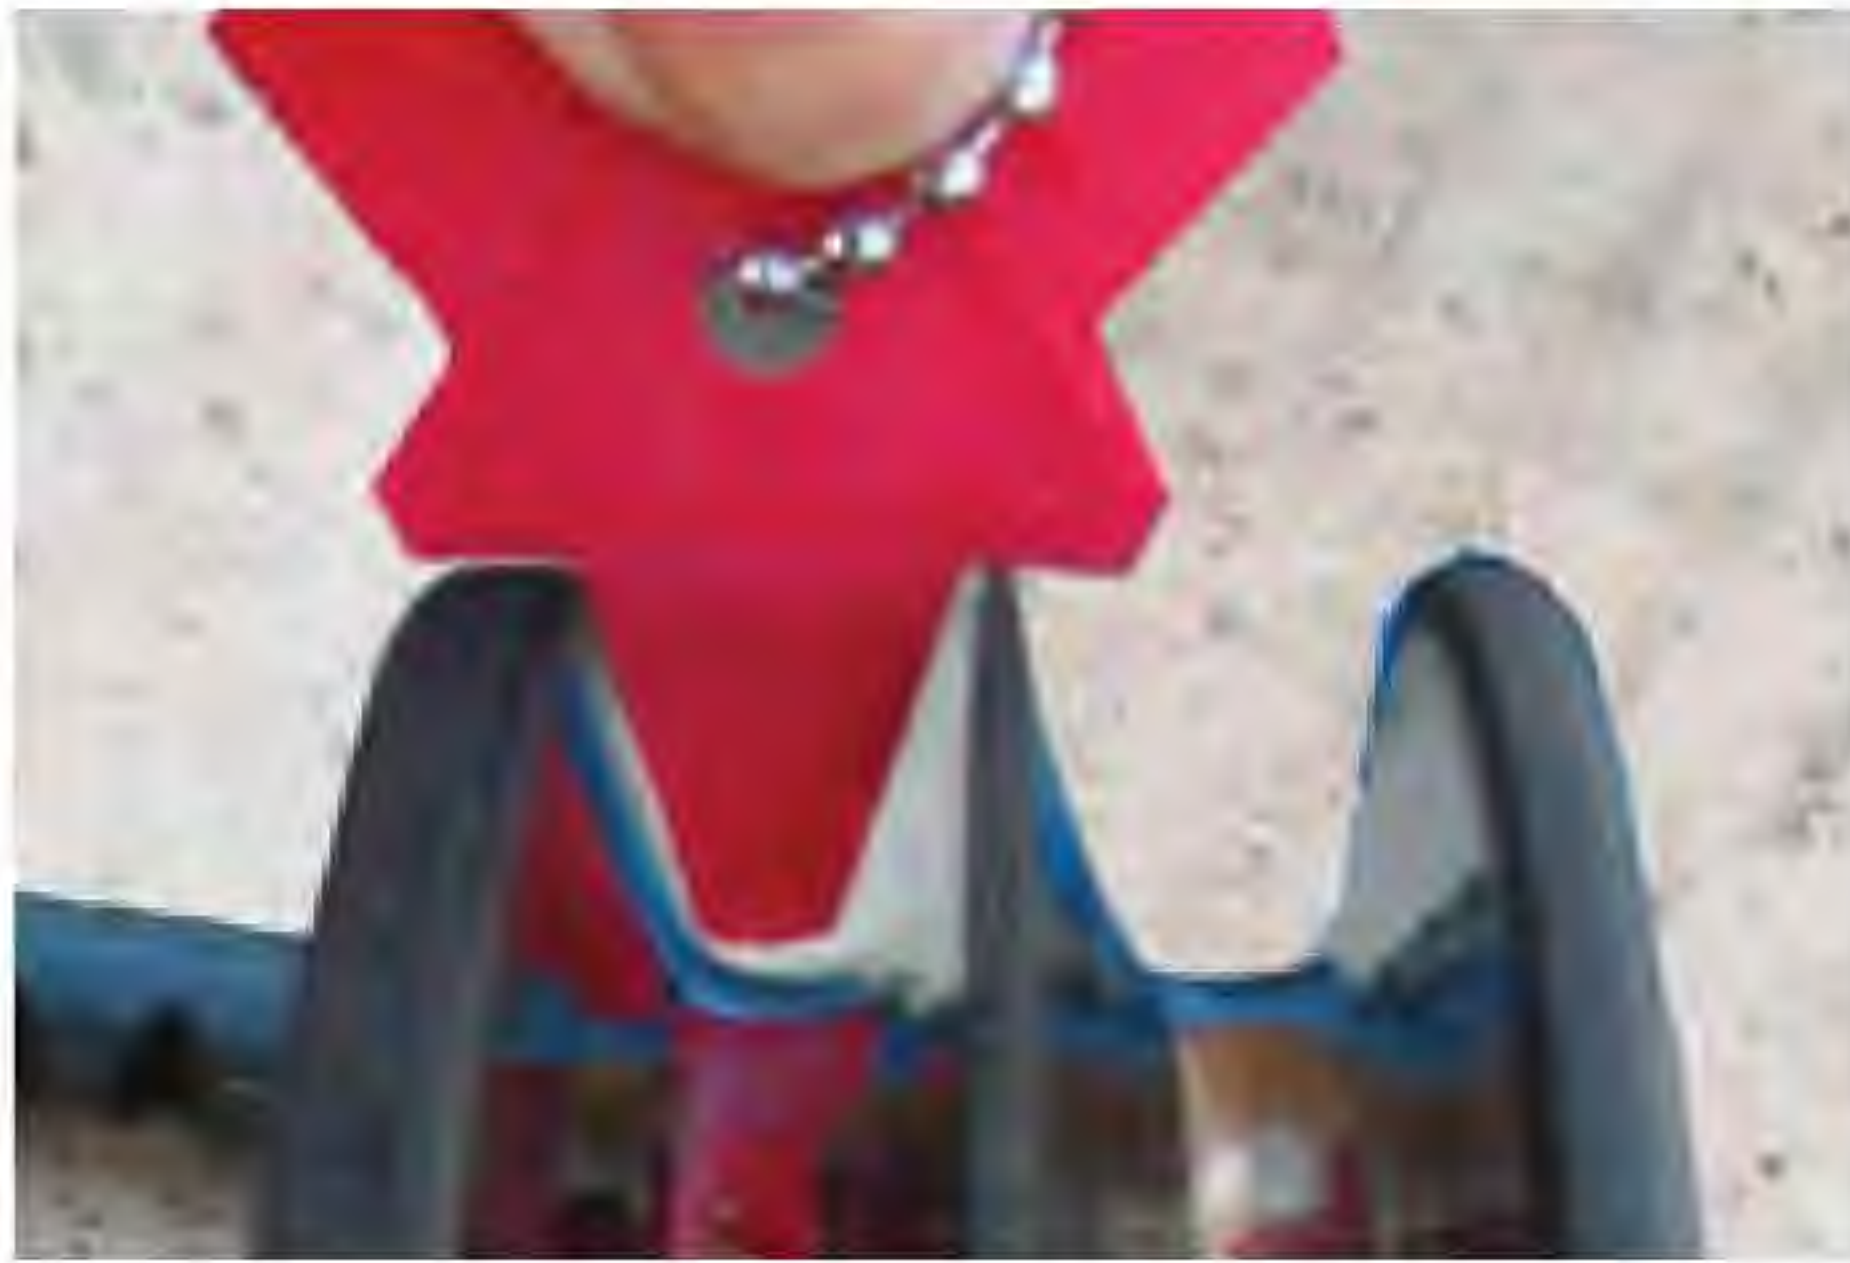
Figure 20 - An investigation into a customer's belt failure complaint identified this severely worn sheave.

It seems improbable that a rubber V-belt could wear out a metal sheave, but it's a fact (see Figure 20). Many users replace V-belts several times without bothering to check the sheaves for wear. Signs of sheave wear include groove sidewall cupping and/or a polished groove sidewall with ridges. Use a sheave gauge (See Figure 21) to detect excessive sheave groove wear, and replace sheaves immediately when worn.
