ANALYZE YOUR WAY TO LONGER LASTING, BETTER PERFORMING V-BELT DRIVES

> Introduction

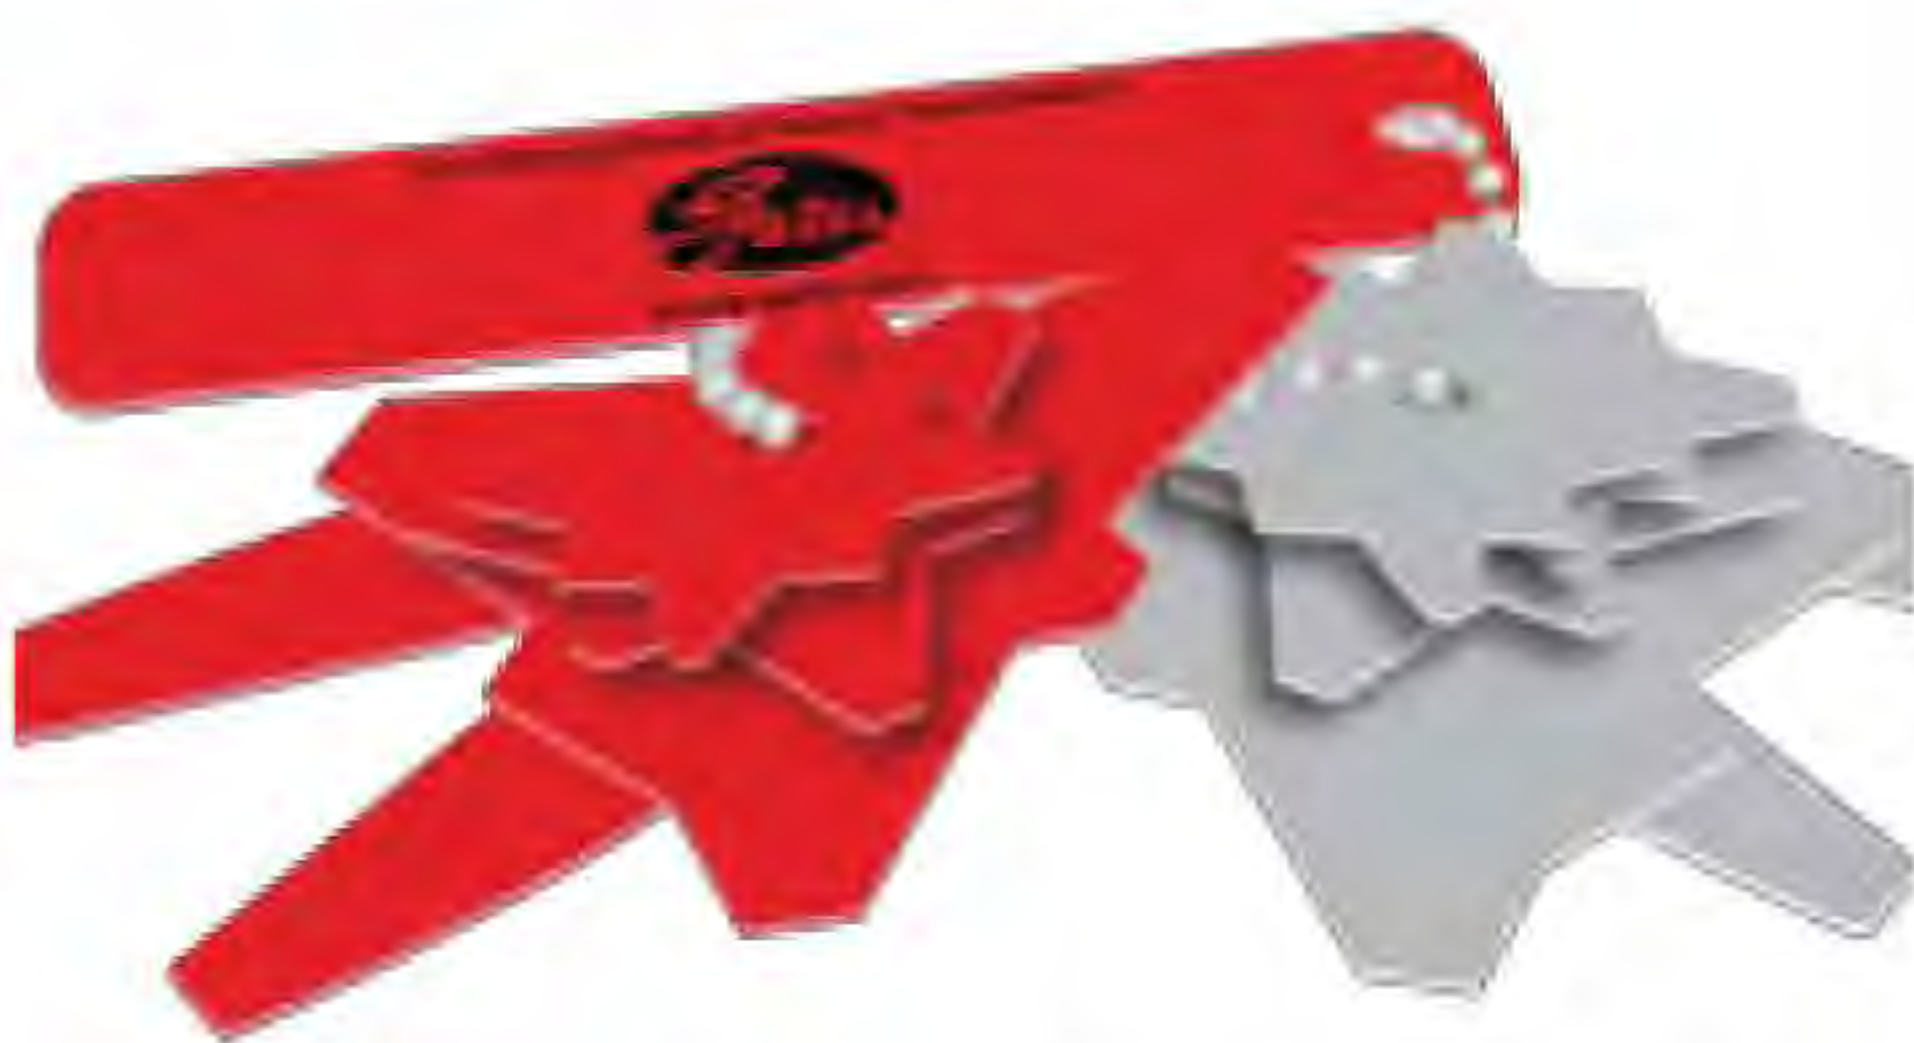
Figure 21 - Gates sheave gauge, product number 7401-0014

It seems improbable that a rubber V-belt could wear out a metal sheave, but it's a fact (see Figure 20). Many users replace V-belts several times without bothering to check the sheaves for wear. Signs of sheave wear include groove sidewall cupping and/or a polished groove sidewall with ridges. Use a sheave gauge (See Figure 21) to detect excessive sheave groove wear, and replace sheaves immediately when worn.
